Manhole Inspection Summary

Manhole # S31EE1020MH

Inspection ☐ Is Incomplete Rating: **3) Fair**

Location Address: **3811 CANTERBURY RD**

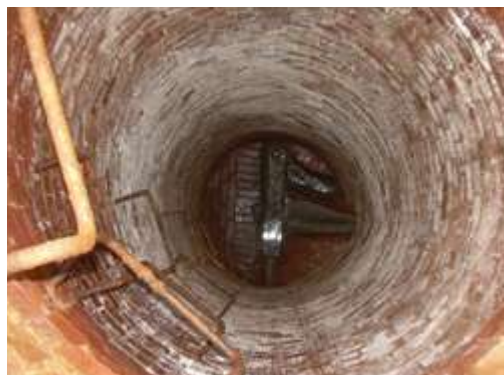
Top View

Steps Count: **10** Missing: **0** ☒ **Corroded**

Corroded steps.

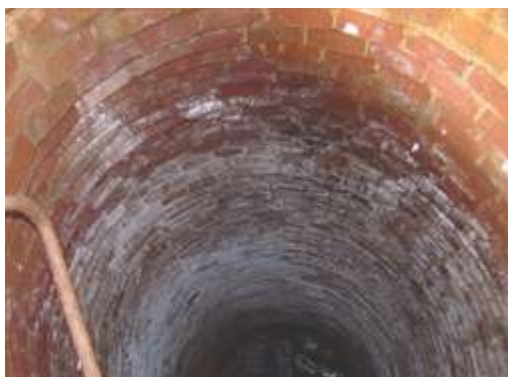
Defect

Infiltration: ☐ None ☒ **Joint** ☐ Cracks ☐ Mortar ☐ Roots ☒ **Wall**

Infiltration: ☐ None ☐ Joint ☐ Cracks ☒ **Mortar** ☐ Roots ☒ **Wall**

Adjustment and Barrel infiltration.

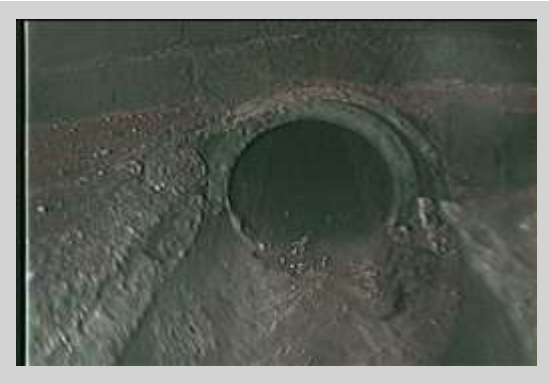
8 in. Circular Gravity Sewer Pipe Out @ 12 O'Clock

Infiltration: **Evidence** Pipe Seal Cond: **Unknown**

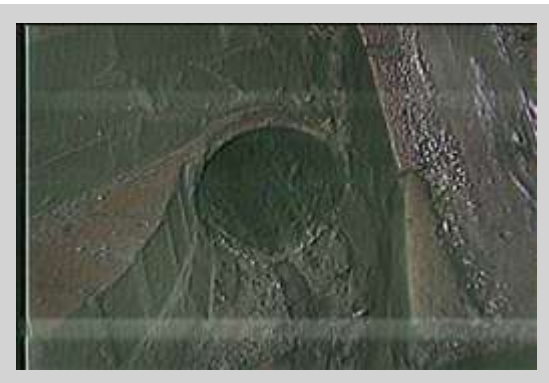
8 in. Circular Gravity Sewer Pipe In @ 3 O'Clock

Infiltration: **Evidence** Pipe Seal Cond: **Cracked**
